# **Field Report for Airborne Data Collected In Support of US EPA Region VI Tri-Chem Industries Fire 15 March 2018**

## **Background**

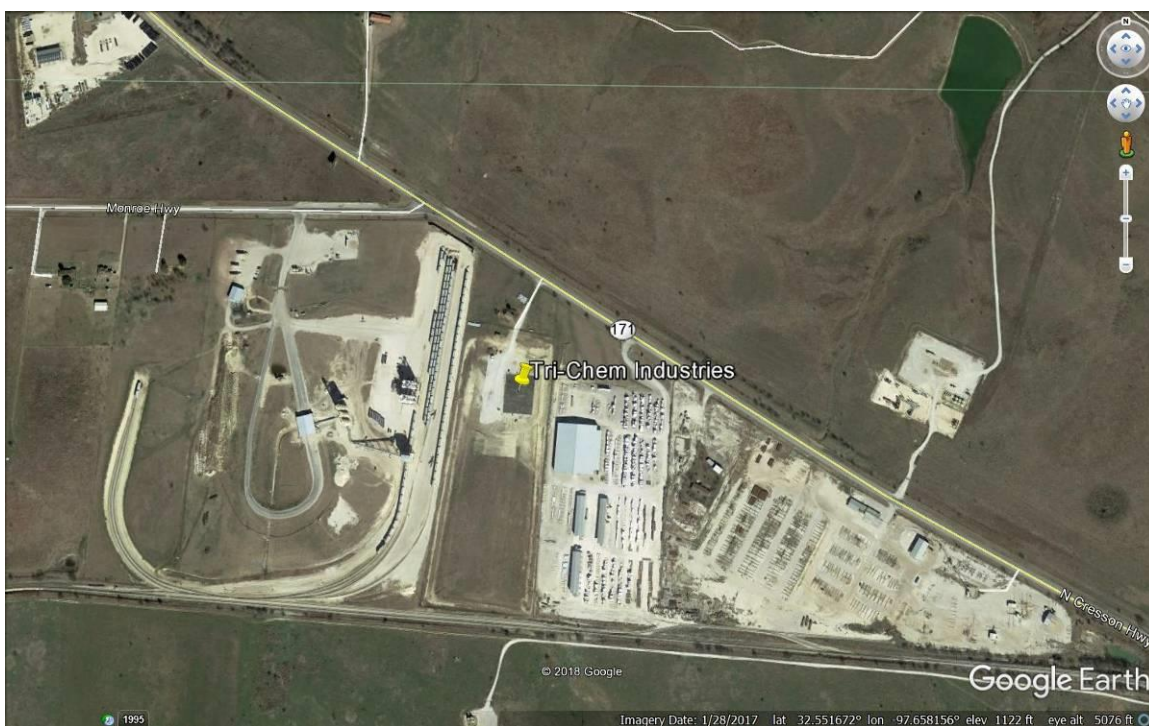
The Tri-Chem facility is located 4.5 kilometers north of Cresson, TX on Cresson Highway. The geographical coordinates of the facility are 32.5520N, 97.6591W (figure 1). The area is a very flat with the town of Cresson being the only nearby residential area.

Figure 1: Tri-Chem Industries, Cresson, TX

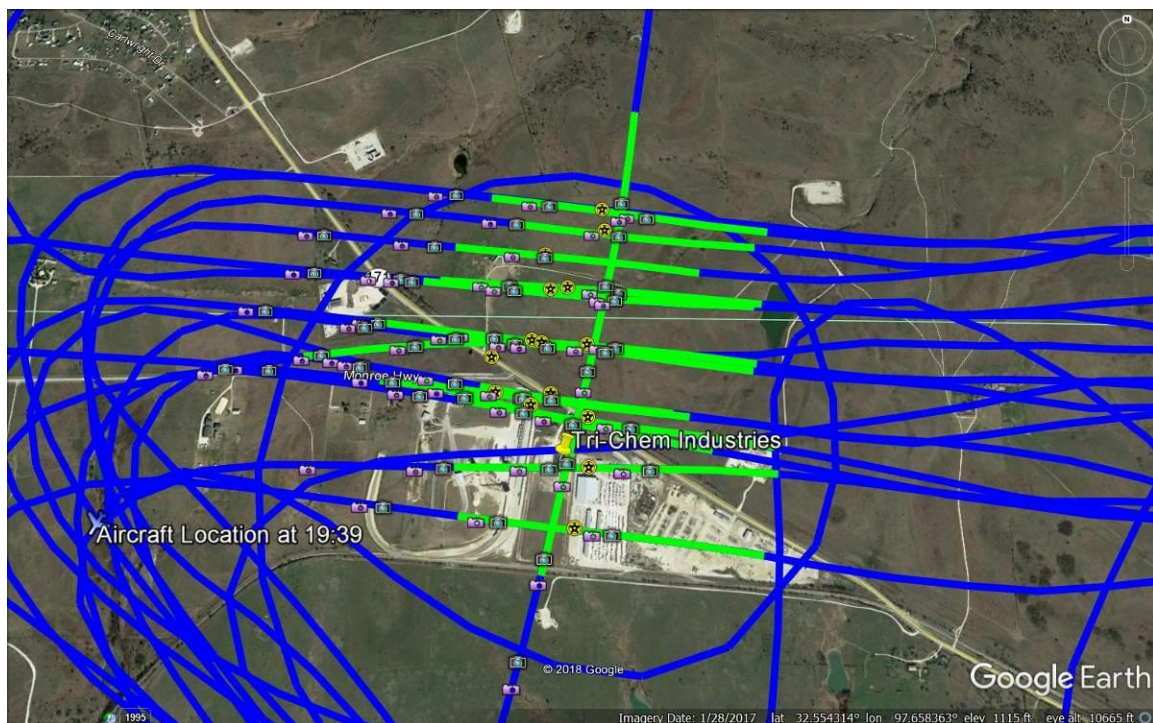
The order to launch the aircraft was given 1305 local on 15 March 2018 and the aircraft was on station at 1330. The aircraft made a total of 15 data collection passes; flight information is summarized in Appendix A and Figure 2.

Figure 2: Data collection passes, Tri-Chem Industries, Cresson, TX

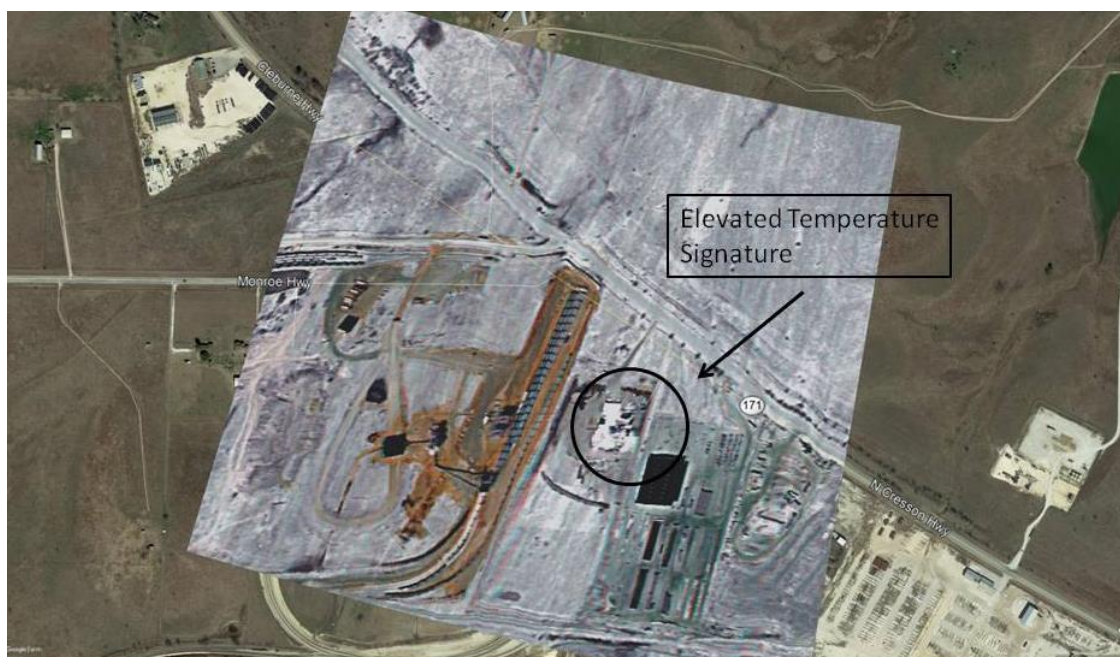
A total of 1 test and 15 data passes were made in the proximity of the site and an infrared line scanner image were generated for each pass. Figure 3 shows a typical 3-band image obtained from data collected in run 15. Objects that are hot will appear white while cold images will appear black. The white shades of the structure indicate that this area of the image is hot; consistent with a fire. No plume was observed in any of the data collection passes.

Figure 3: – 3 band IR image, Run 15, Tri-Chem Industries

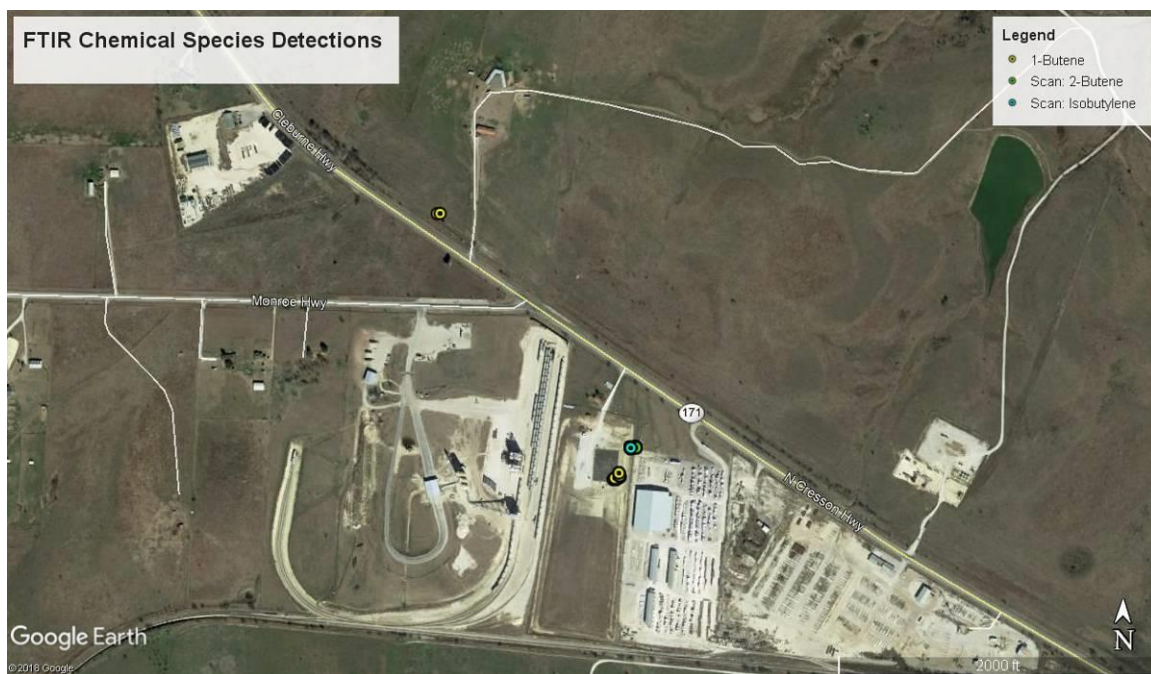
Organic compounds including 1-butene, 2-butene and isobutylene were observed in three data passes with the locations given in Figure 4. These compounds are common products of combustion. On data pass 3 an isolated and low level detection of 1-butene was made north of the facility (downwind) and across the highway. On pass 15 and 16 the system was flown approximately 50 meters downwind of the facility building. These passes showed several compounds including 1-butene, 2-butene, isobutylene and a very low concentration of allyl alcohol; all below 2 ppm. Additional compounds were also detected and included ozone and peroxyacyl nitrates (PAN) being generated by the hot fire. Post analysis of data showed a low presence of acetone with a maximum concentration of 0.7 ppm. A summary of the chemical detections is given in Table 2. A typical example of confirmation spectra is given in Figure 5. This image shows isobutylene characteristic of the major peak located at 890 wavenumbers.

Figure 4: Chemical Detection Locations, Tri-Chem Industries

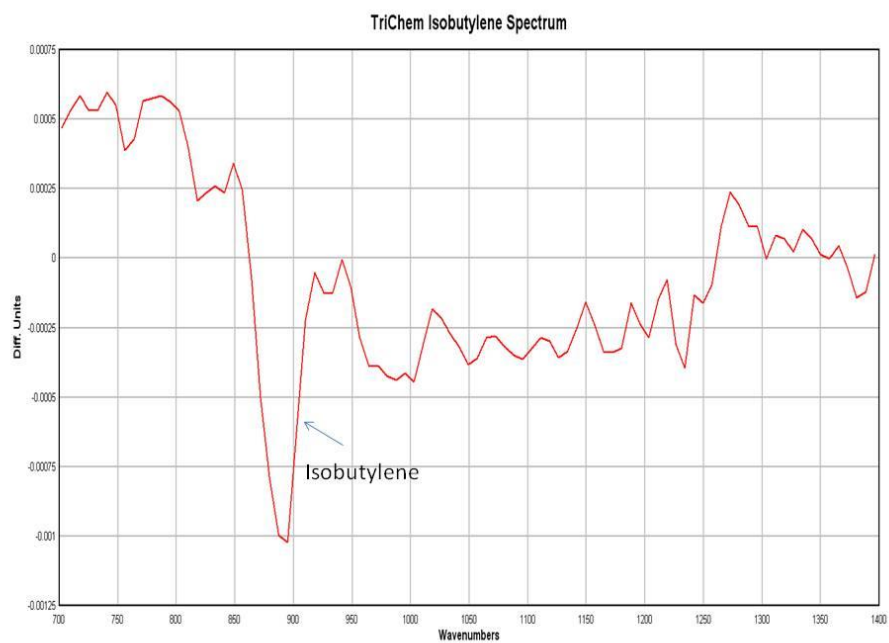
Figure 5: Isobutylene Spectra, Tri-Chem Industries

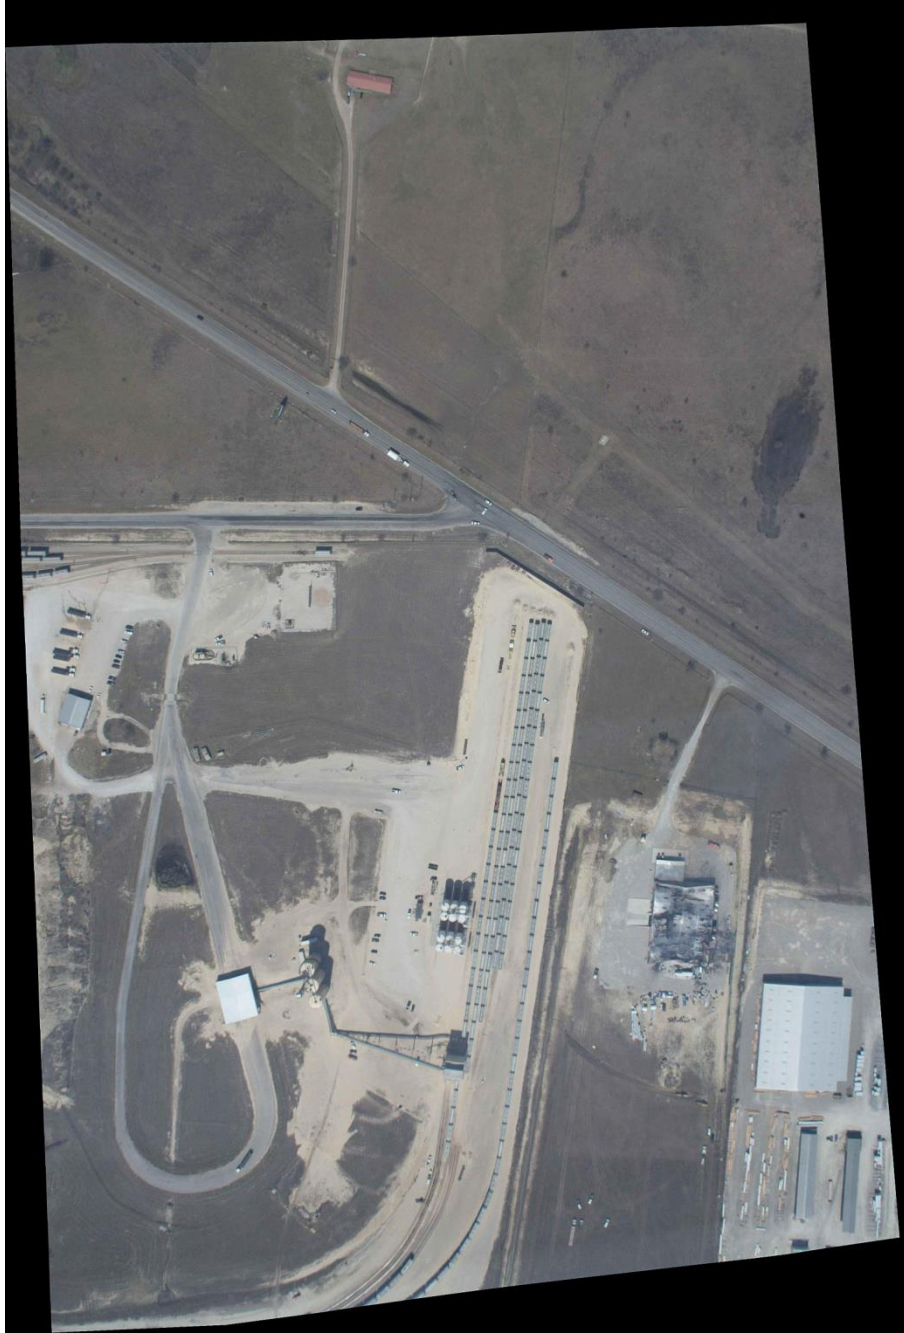
A full set of high resolution aerial digital photography was collected as part of the flight. Figure 6 shows a representative image collected as part of Run 5. This image has been orthorectified with the top of the image being north. The facility which is located in the center of the frame clearly shows damage to the roof. Close examination shows the presence of a very light plume moving to the north. Figure 7 shows a typical oblique image collected from the right side of the aircraft. This image is not geo-rectified. The top of the image is looking to the east. Examination of the image clearly shows the extent of collapse of the roof with a small amount of smoke being emitted on the southern part of the building.

Figure 6: Aerial image Tri-Chem Industries
